# SR70 Gatehouse Renovation

Before and after photos

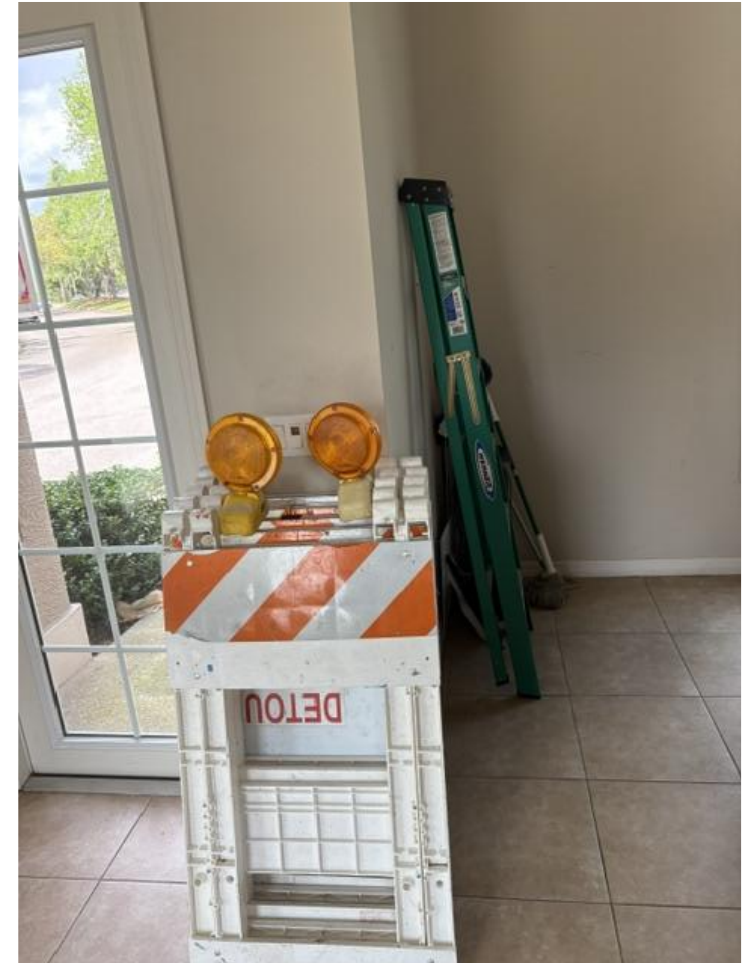
Barricades, needed from time to time, but nowhere to conveniently place them.

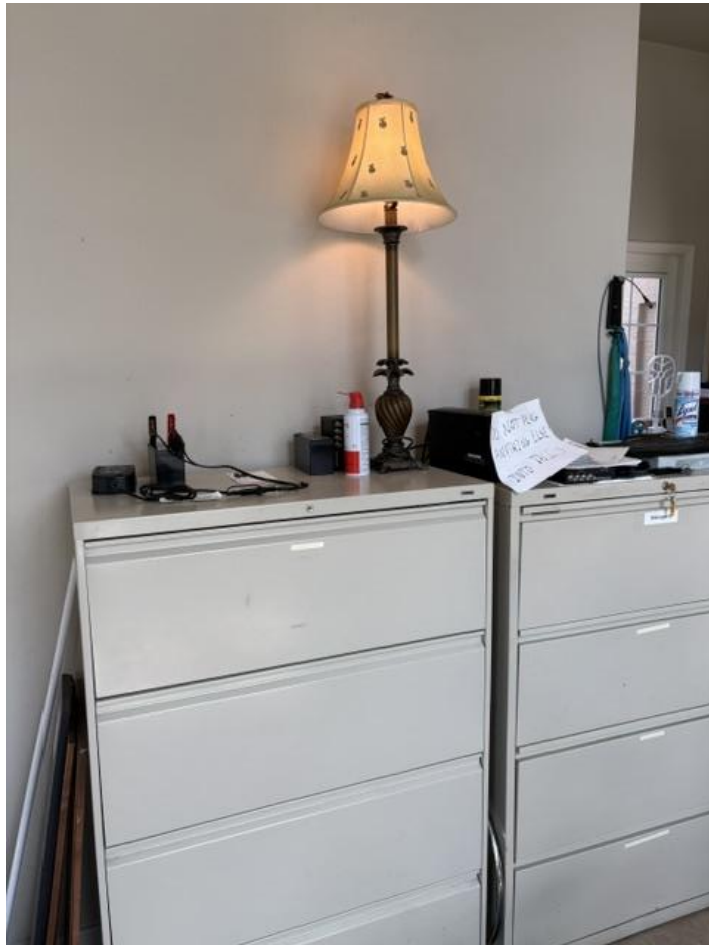
Old filing cabinets  
used for storage and  
shelving. Computer  
and access  
equipment strewn  
on the top.

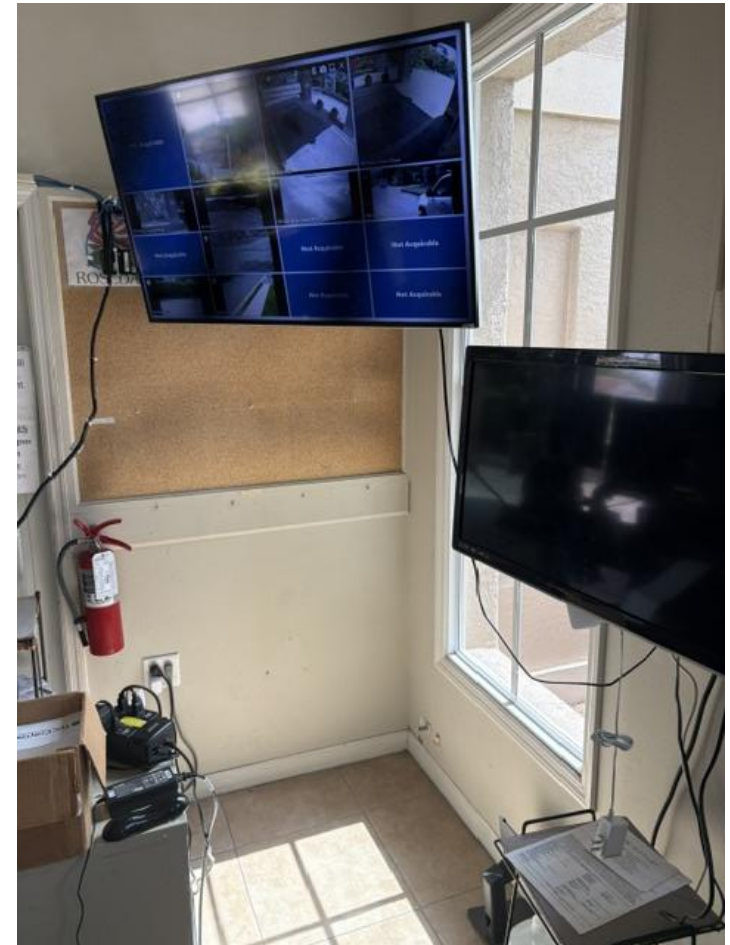
Front corner with  
camera monitors and  
warped cork board.

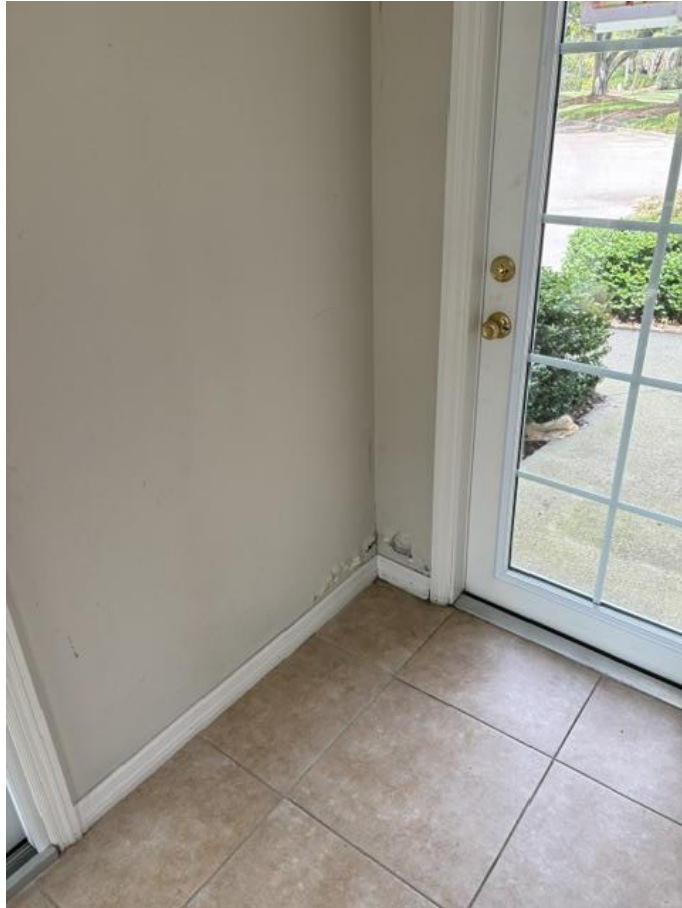
Water damage in wall near pedestrian door. Door frame was completely rotted out.

Replaced rotted pedestrian door and raised threshold to prevent water from entering building.

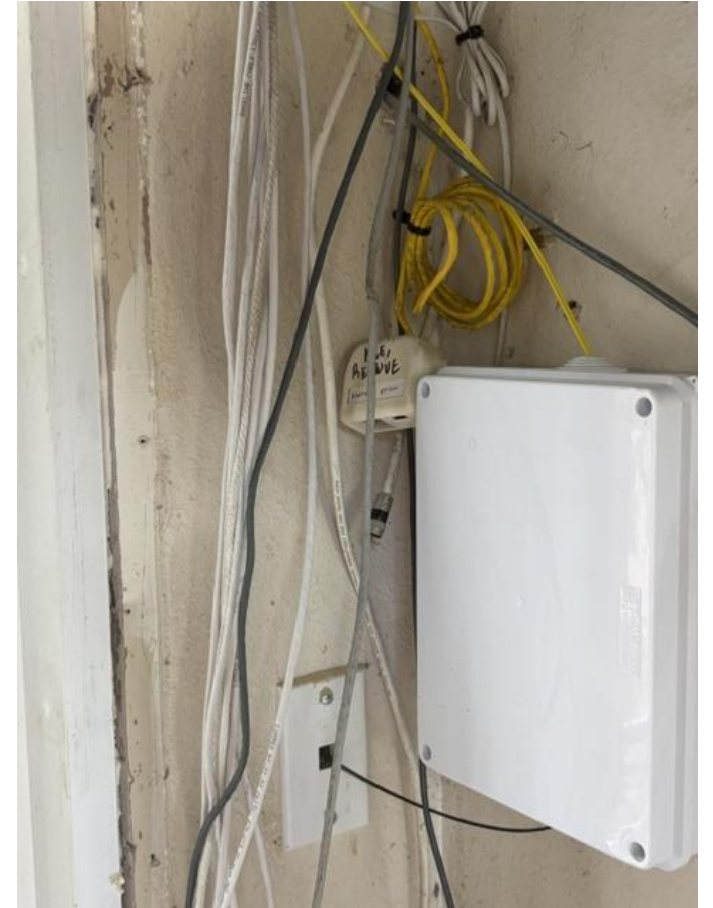
Example of old wiring – loose cables everywhere.

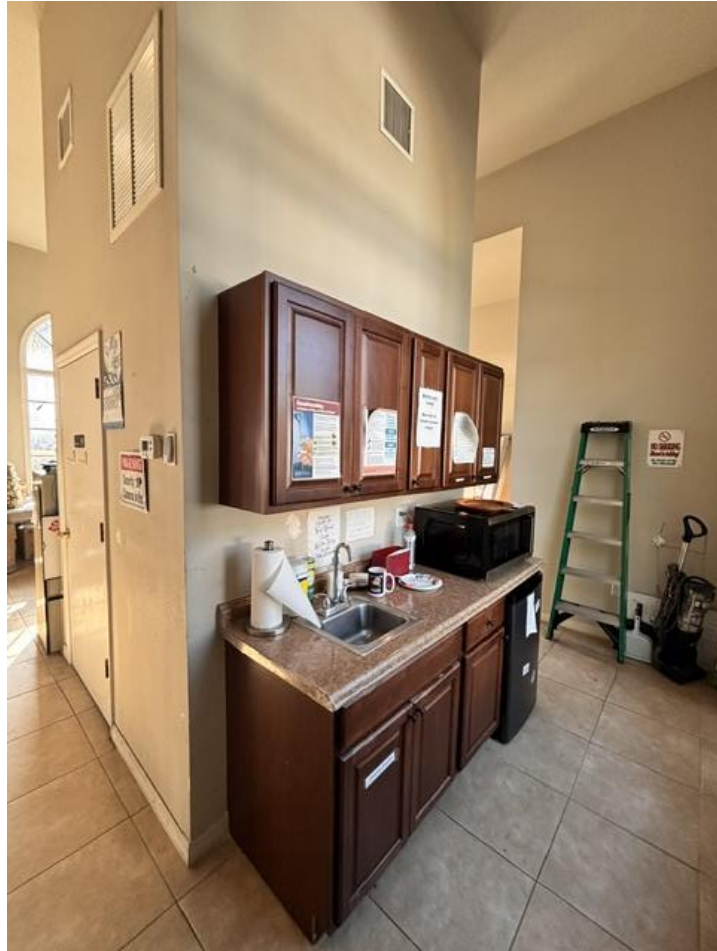
Kitchenette cabinets  
and countertop.  
Cabinets were rotted  
out, fixtures were  
corroded.

Replaced rotted cabinets in kitchenette with new cabinets matching cabinets for access equipment and storage. Counter top donated by local resident. New sink, faucet and garbage disposal.

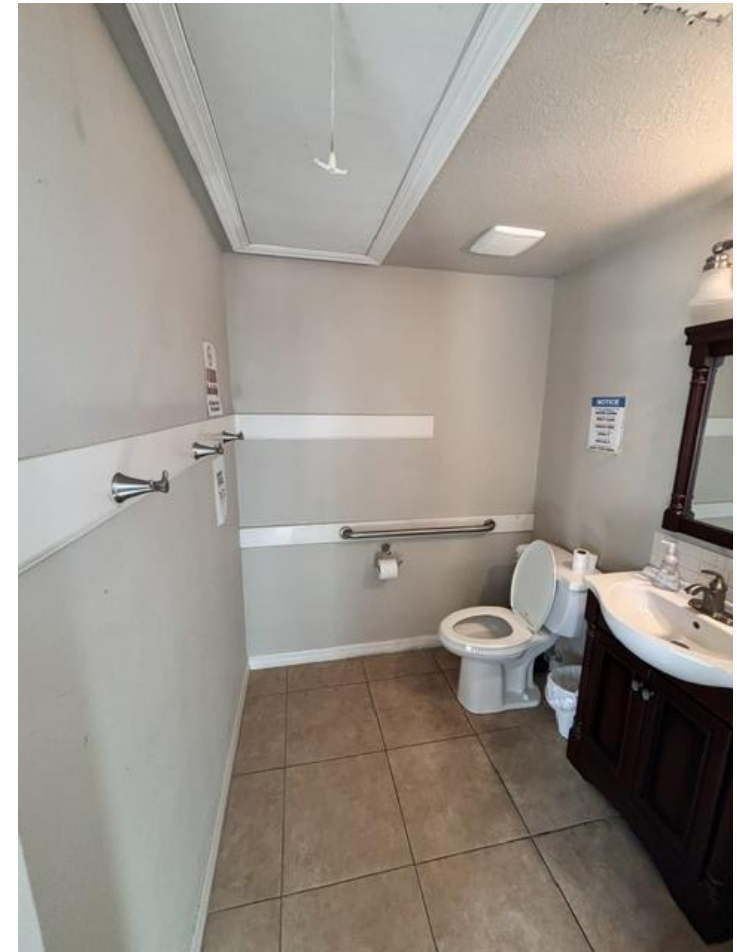
Bathroom – rotted  
vanity, corroded  
faucet, lights not  
working.

Bathroom completely redone – new toilet, vanity, faucets, mirror and lights. Now everything works.

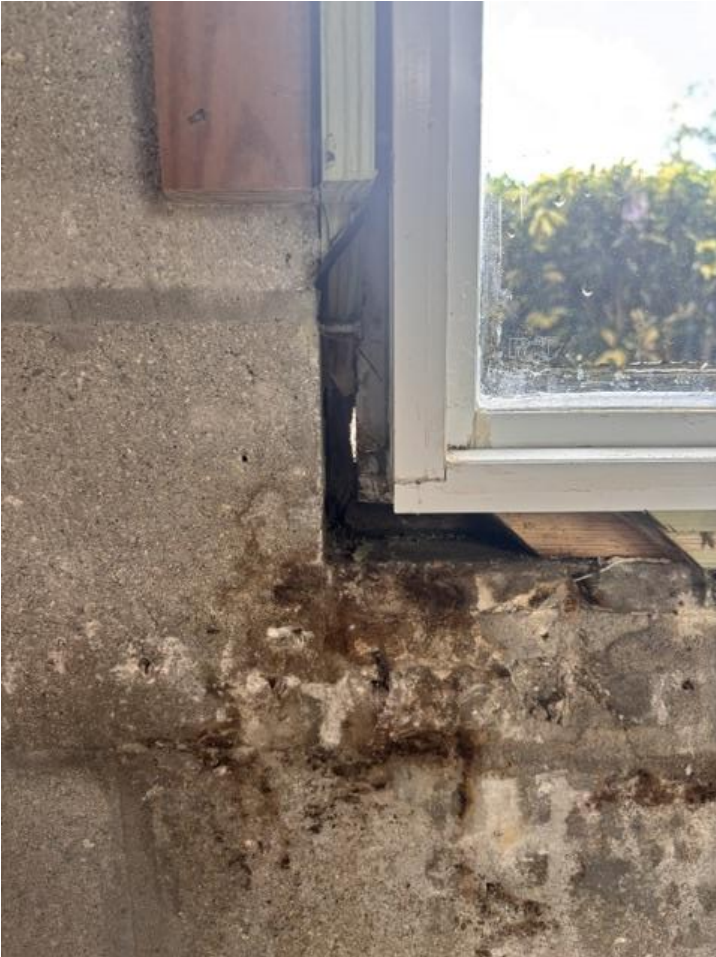
Water damage around entire lower interior of building. You can see gap in window where water was coming in. Similar situation in all the other windows in the building.
